**A Review of Australian and
New Zealand Investigations
on Aeronautical Fatigue
During the Period April 2001
to March 2003**

DSTO-TN-0489

Air Vehicles Division
Platforms Sciences Laboratory

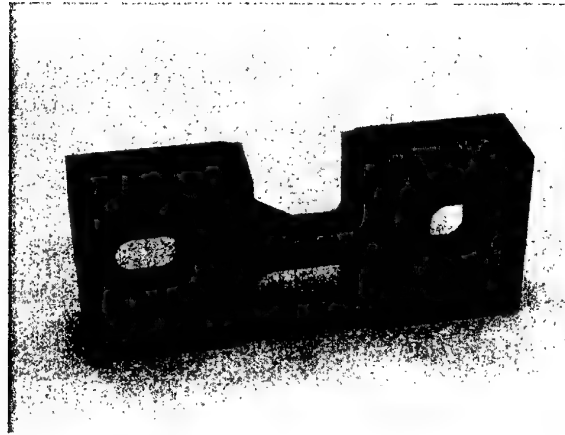
Figure 12: SRO #2 Representative Specimen

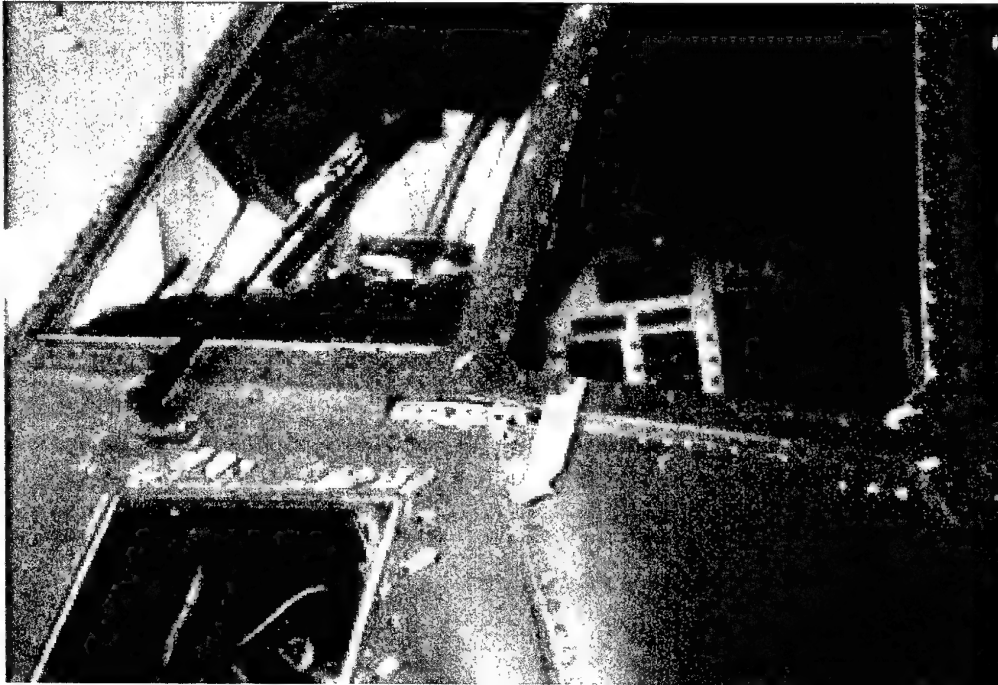
Figure 69: Close up of corroded area, showing the large doubler.
